Evaluation of Cracking in Pre-service and In-service Snow Plow Carbide Wear Surfaces

Research Investigation RI 01-023

Research Number RDT 03-015

Missouri Department of Transportation

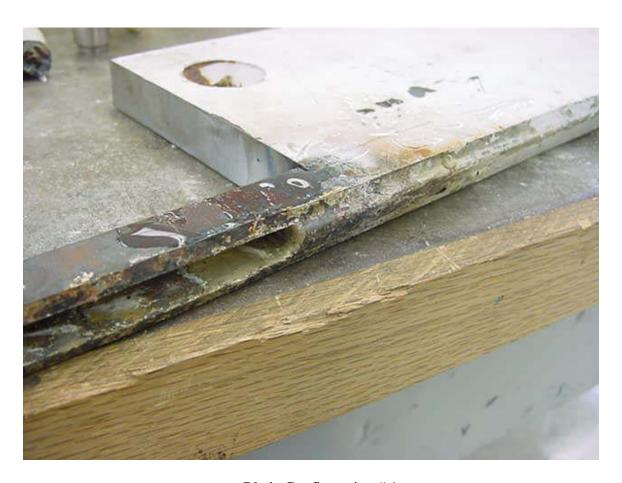
Blade Configuration # 1

The above photograph shows the configuration of the blade, and also the areas of the blade that were cut out, and the carbide inserts removed for receipt inspection tests. As can be seen from the blade photograph and cross section dimensions, the best surface area for a contact ultrasound scan is the front of the blade due to the wider insert configuration on this side. Because the insert height is only .75" tall and it is located about .3" from the transducer face, beam-spread is a consideration. I set up a calibration (DELAY2), which utilizes a delay line shoe on a 5 MHz .5" round KBA Alpha MSW-QC style transducer. A delay line Lucite shoe moves (delays) the inspection volume out in time on the CRT baseline and was used to maximize use of the transducer focal length

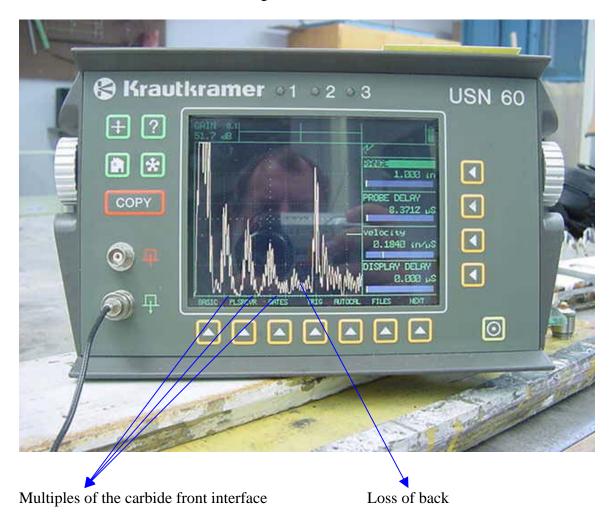
Screen showing lack of bond area;

It appears that insufficient heat during brazing may have been the cause of these bond problems. Inserts were numbered from left to right when looking at the front (broad face) of the blade in order to establish uniformity in insert identification during the monitoring program. The two replacement blades, numbered 11C1B290 and 1011859 exhibited no ultrasonic defects, however small insufficient braze voids were noted visually in a few locations. The blades, #11C1B290 and 1011859 were found acceptable to present acceptance criteria, but one small area of lack of bond was found on insert # 32 of blade 11C1B290, and blade # 1011859 had a small area of lack of bond on insert # 11 and a

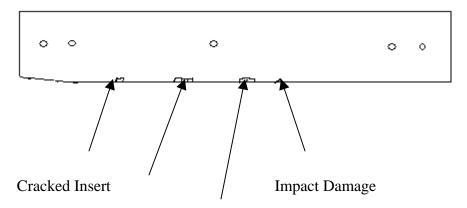
Blade # 1

3 Cracked Inserts

2 Cracked Inserts

Blade number 1 is one of the blades that were inspected using visual, ultrasound and penetrant examinations in the lab prior to blade use. The blade is mounted on the right hand (roadway edge) of the plow. The outer edge of the blade is worn back about 6".

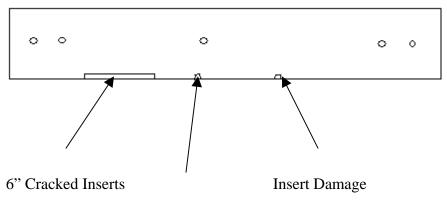
Blade #3

Cracked Insert

Blade # 3 Looking from front of plow

Blade # 3 is one of the blades that were inspected using visual, ultrasound and penetrant examinations in the lab prior to blade use. The blade is mounted on the inboard left side of the plow facing forward. The bottom edge of the blade is worn, but because it does not sit quite as low on the plow as the other blades, it has not received the forces that the other blades have experienced.

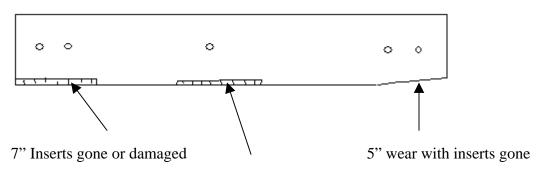
Blade #4

8" All inserts Damaged

Blade # 4 is mounted on the outboard left side of the plow facing forward. The bottom edge of the blade is worn, and there is significant carbide insert damage on the inboard end of the blade, significant insert damage in the center of the blade and about five inches of wear including loss of inserts in the outboard end.

It was noted during field evaluation that the above damage to the blades was either due to impact damage and migrating damage emanating from the initial point of damage, or wear and contact damage located at the outer edges of the plow. It appears that blades with backing blades installed have less splintering of carbide than blades that have no front or back protective plate. However, with the exception of blades used at the Ashland maintenance facility, blades with a backing plate have significantly more shattering than blades with plates mounted on the front of the carbide blade. There may be many reasons for this, but we have found that the front mounted plate seems to better support the carbide insert blade, which allows the blade to "wear in" to a stable, better-protected configuration. Once the blade insert is worn flat, the blade seems to wear evenly and without significant shattering until the inserts thin to less than $1/8^{th}$ inch, at which point rapidly changing heat parameters within the thin carbide coupled with minimal remaining braze and other influences causes the inserts to shatter and/or leave the machined blade slot altogether.
